Tricuspid Stenosis after Pacemaker Implantation Without Evidence of Bacterial Endocarditis. A Case Report

Tricuspid stenosis related to endocardial pacemaker leads is uncommon. We report the case of a patient with severe tricuspid stenosis documented 15 years after the implantation of a permanent DDD pacemaker for symptomatic congenital heart block. The atrial and ventricular leads both had a loop at the level of the tricuspid valve that may have caused endothelial damage and, eventually, tricuspid stenosis.

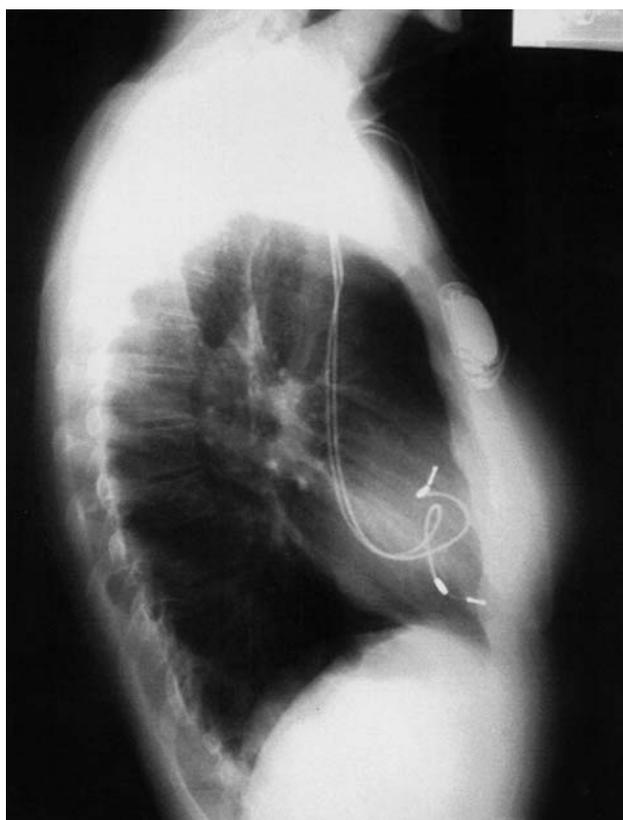
Fig. 1A. Lateral chest radiograph one year after implantation of the first pacemaker. Observe the loop formed by the atrial and ventricular electrodes on the tricuspid plane.

In this case (Figure 1A) both the atrial and ventricular electrodes form a loop on the plane of the tricuspid valve and can trigger stenosis, since findings of

endocarditis never existed. As López-Gil et al¹¹ indicate, adequate proximal fixation of the electrode can prevent the formation of loops, and early correction can avoid damage to the tricuspid valve. Medical treatment was indicated since there were no finding of endocarditis and the patient had an excellent functional class. It is important to note that the appearance of clinical manifestations suggestive of right heart failure in any patient with a pacemaker should suggest the possibility of tricuspid stenosis. Any redundant intracavitary electrode that presents a loop in the tricuspid valve, or shows signs of infection (in some cases the loop itself may predispose to infection), can give rise to tricuspid stenosis.

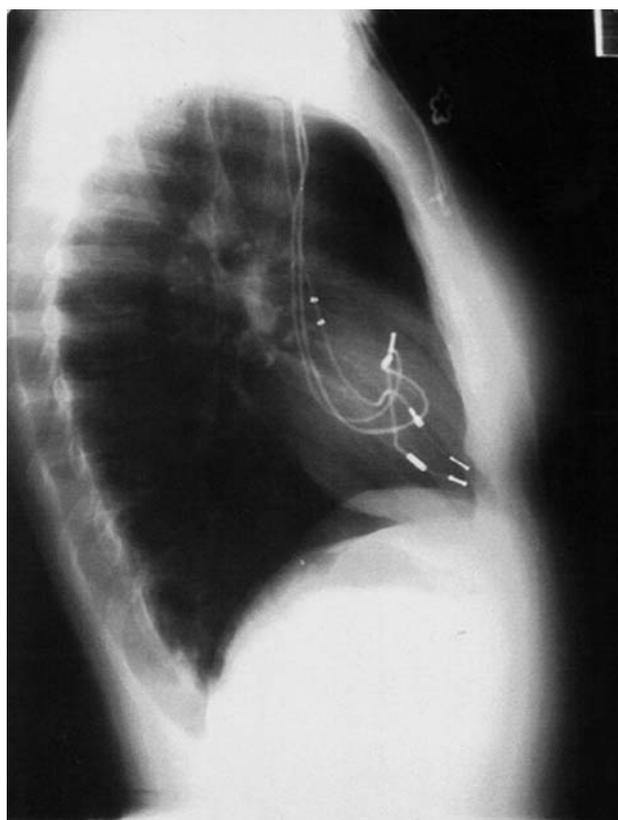
Fig. 1B. Lateral chest radiograph after implantation of the new system.

new VDD pacemaker was implanted in the right subclavian, leaving the two old electrodes in the pouch (Figures 1A and B).

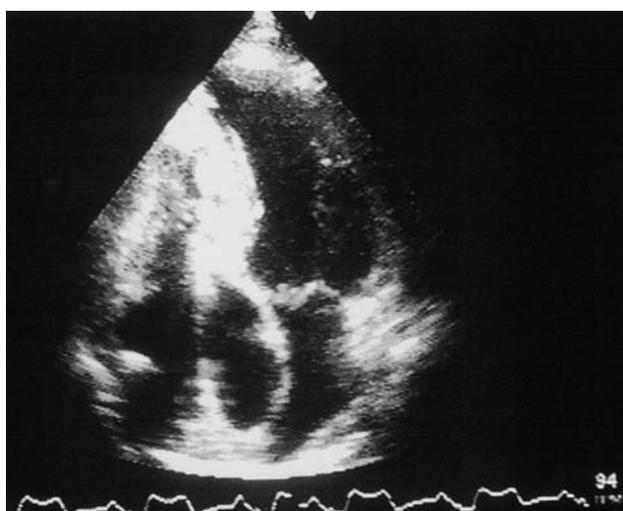
Fig. 2A. 2D echocardiogram, 4-chamber view. Right atrial dilatation and valvular thickening are observed.

The echocardiogram (Figures 2A and B) revealed a tricuspid valve with thickened leaflets and adherence of the ventricular electrode to the septal leaflet producing severe stenosis (mean gradient of 9.9 mm Hg, area 1 cm²), and the atrial electrode adhered to the tricuspid valve plane. An exercise stress test was carried out, which had to be interrupted at the end of the third phase. The decision was made to administer medical treatment.

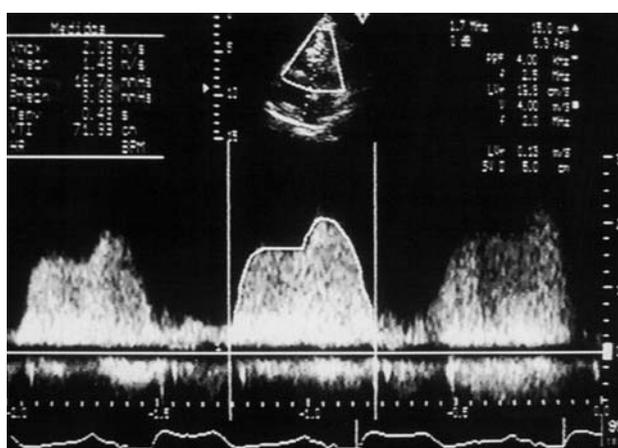
Fig. 2B. Doppler ultrasound of the tricuspid valve with a mean gradient of 9.9 mm Hg.
